**Flood Control Project Maintenance
Levee Inspections**
LMA District Cover Sheet
Spring 2018 Levee Inspection Results

Reclamation District No. 1600 Mull

Spring 2018 Levee Inspection Results

Levee Inspection Report By Mile - Spring 2018

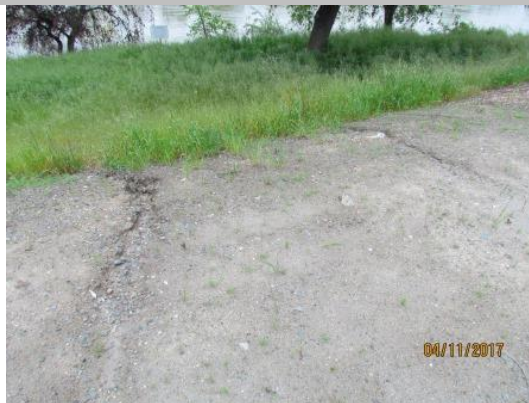
Photo 1 of 1 : SP_2018_RD1600_191_46_20180306_00040.jpg

Rills from runoff on waterside levee slope. Spring 2017.

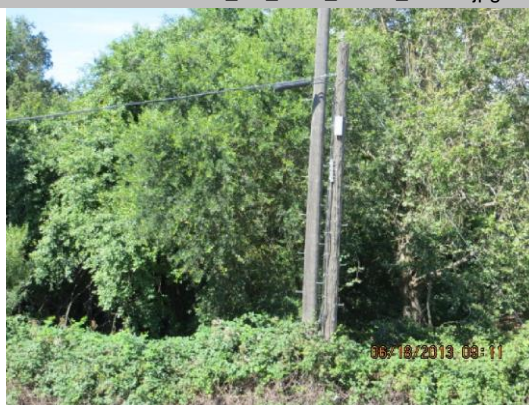
Photo 1 of 1 : UCIP_SP_2018_15087_24812.jpg

LM Start	0.13	Rating **	M	Issue No.	1203
LM End	0.13	Issue Type +	En	Location *	
Category	Supplemental			GPS Latitude/Longitude	
				Start	End
Item	DWR UCIP Field Study			38.676802 °	38.676802 °
				-121.631442 °	-121.631442 °
DWR ID					
Comment Code					
Inspector Comment					
FS_ID:15087 DS_ID:21459 EP_NO: 1929 Repair Type: Non-Urgent Crossing Status: Indicator Found UCIP Comments: Line should be located with carsonite signs on both sides of levee. FIELD_STRUCT_DESC: Telephone conduit of an unknown size or material through the levee, 3 feet below the crown. Telephone line at joint pole (JP) off the landside (LS) toe. (Permit No. 1929, 1954 - Pacific Telephone and Telegraph Company [PT&T]). [Additional Reference(s): DWR Levee Log, 1988]. FS Date: 6/18/2013

Line visible on JP off LS toe. Likely this is the source of crossing.

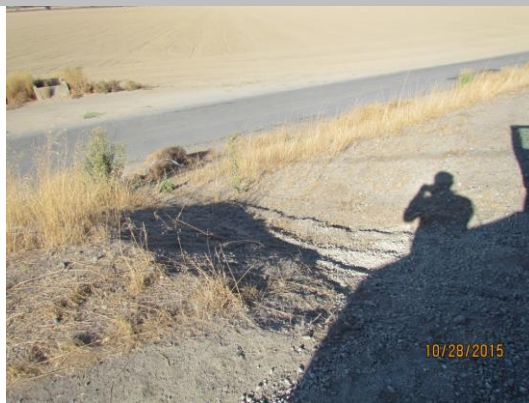
Photo 2 of 2 : SP_2018_RD1600_191_133_20180306_00062.jpg

View of the slope stability on the landward side of the levee. Fall 2015.

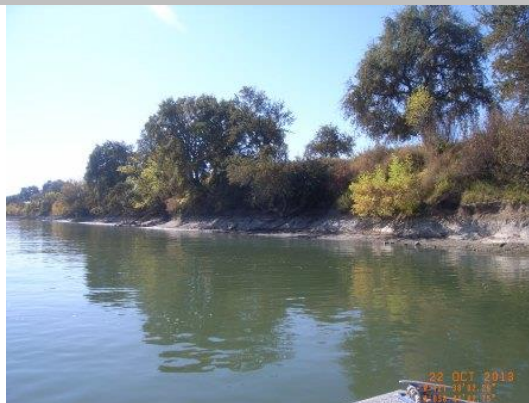
Photo 1 of 1 : SP_2018_RD1600_191_7_20180306_00009.jpg

LM Start	0.56	Rating **	A/W	Issue No.	7
LM End	0.66	Issue Type +	Ma	Location *	WS
Category	Supplemental			GPS Latitude/Longitude	
				Start	End
Item	2015 USACE Erosion Survey, DRAFT			38.682707 °	38.684106 °
				-121.633830 °	-121.634219 °
DWR ID	DWR_RD1600_01_s_2016_7				
Comment Code					
Inspector Comment					
2000 - Very cohesive vertical bank. 2003 - Some minor new erosion. 2006 - Some minor erosion in old pockets. 2009 - Minimal new erosion. 2011 - Multiple new erosion pockets and a few new tree popouts. 2015: No observed changes. [2015 Site ID: SAC_71-3_R]

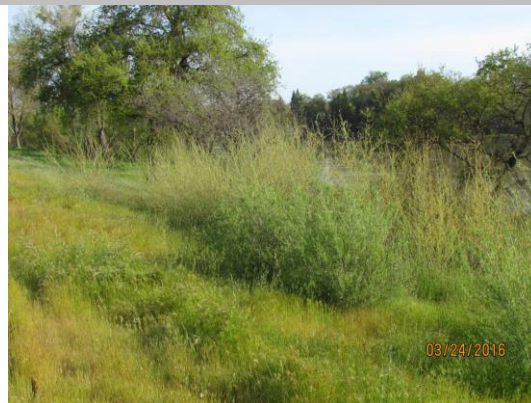
Photo 1 of 3 : SP_2018_RD1600_191_29_20180306_00029.jpg

LM Start	0.60	Rating **	M	Issue No.	29
LM End	0.62	Issue Type +	Ma	Location *	WS
Category	Earthen Levee			GPS Latitude/Longitude	
				Start	End
Item	Vegetation			38.683238 °	38.683415 °
				-121.634388 °	-121.634448 °
DWR ID	DWR_RD1600_01_s_2016_29				
Comment Code					
V2 : Remove the wild growth other than native grasses from the levee slopes.					
Inspector Comment					
Recommend removal of willow trees.

Perspective view of the willows on the waterward side of the levee looking upstream. Spring 2016.

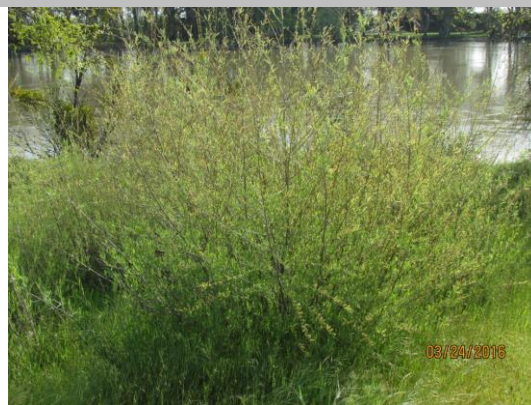
Photo 2 of 3 : SP_2018_RD1600_191_29_20180306_00030.jpg

Willows are growing on the waterward side of the levee. Spring 2016.

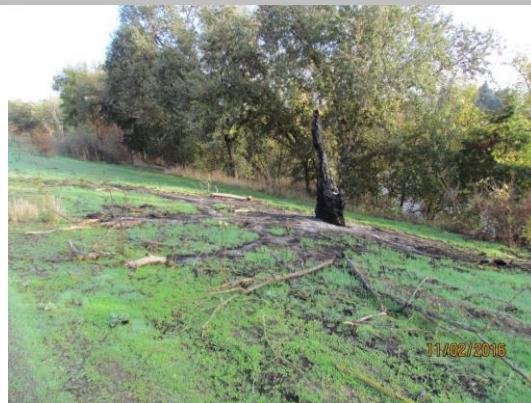
Photo 1 of 1 : SP_2018_RD1600_191_624_20180306_00068.jpg

LM Start	0.78	Rating **	N	Issue No.	624
LM End	0.78	Issue Type +	Ma	Location *	WS
Category	Earthen Levee			GPS Latitude/Longitude	
				Start	End
Item	Trim / Thin Trees			38.685713 °	38.685713 °
				-121.634985 °	-121.634985 °
DWR ID	DWR_RD1600_01_s_2017_624				
Comment Code					
T5 : Tree stumps.					
Inspector Comment					
Burnt stump on waterside slope.

View of burnt tree on waterside slope. Fall 2016.

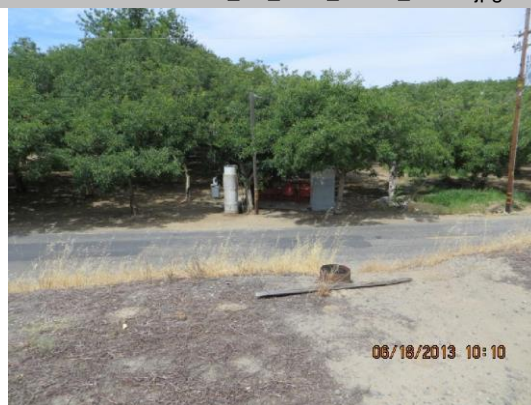
Photo 1 of 3 : UCIP_SP_2018_15285_25088.jpg

Comment Code						
Inspector Comment						
FS_ID:15285 DS_ID:21463 EP_NO: 6100 Repair Type: Non-Urgent Crossing Status: Found UCIP Comments: Gate valve will not open or close. FIELD_STRUCT_DESC: 12-inch steel irrigation pipe through the levee, 3.4 feet below the crown. Slant pump and gate valve on the waterside (WS) slope. Siphon breaker in a 12-inch steel riser on the landside (LS) shoulder. Filter, booster pump, and butterfly valve on the LS toe. 2.25-inch galvanized iron electrical conduit at the same location. (Permit No. 6100, 1968 - Charles Plumb Jr., replaced 8-inch pipe at same location). [Additional Reference(s): DWR Levee Log, 1988]. FS Date: 6/18/2013

Siphon breaker in steel riser on LS shoulder and concrete standpipe off LS toe.

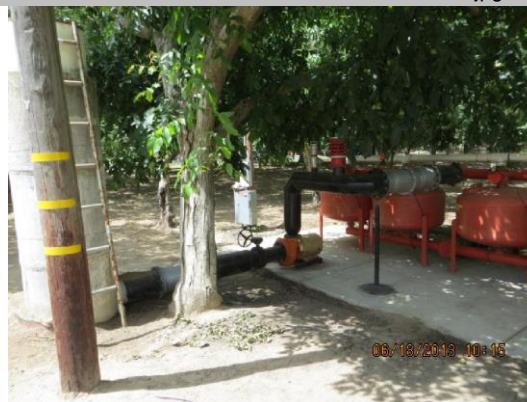
Photo 3 of 3 : UCIP_SP_2018_15285_25086.jpg

Filters, boost pump, and gate valve down stream from concrete standpipe off LS toe.

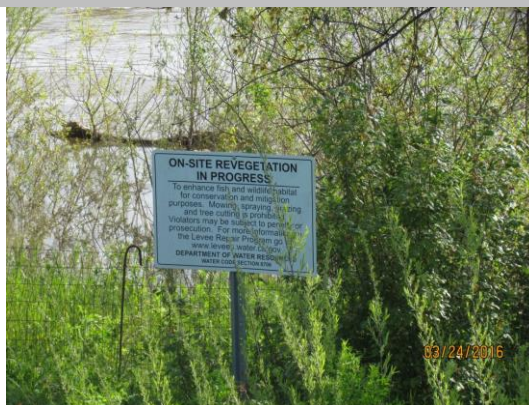
Photo 2 of 2 : SP_2018_RD1600_191_22_20180306_00022.jpg

Sign stating revegetation site. Spring 2016.

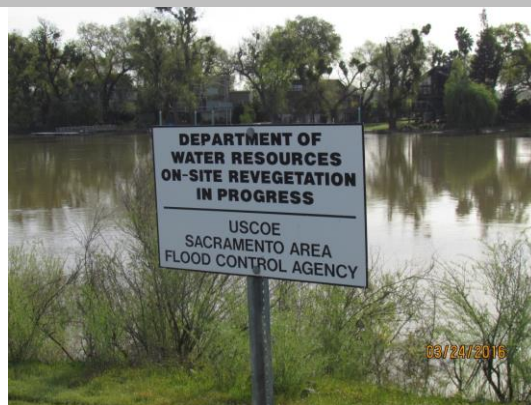
Photo 2 of 2 : SP_2018_RD1600_191_5_20180306_00007.jpg

DWR revegetation site. Spring 2016.

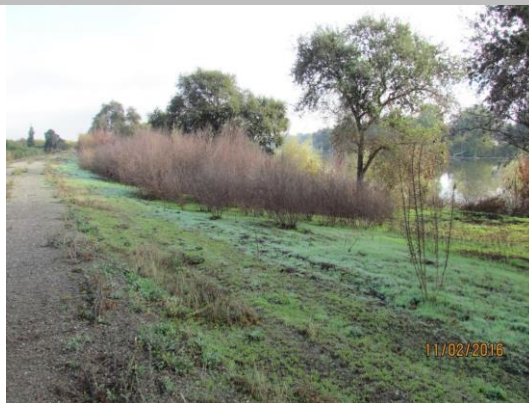
Photo 1 of 1 : SP_2018_RD1600_191_50_20180306_00043.jpg

LM Start	1.53	Rating **	M	Issue No.	50
LM End	1.58	Issue Type +	Ma	Location *	WS
Category	Earthen Levee			GPS Latitude/Longitude	
				Start	End
Item	Vegetation			38.696341 °	38.696918 °
				-121.633417 °	-121.633044 °
DWR ID	DWR_RD1600_01_s_2016_50				
Comment Code					
V2 : Remove the wild growth other than native grasses from the levee slopes.					
Inspector Comment					
Recommend removal of willows on waterward side of the levee.

View of willows on waterward side of the levee. Recommended removal. Fall 2016.

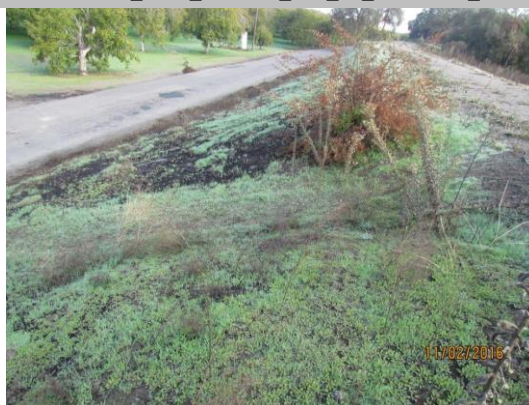
Photo 1 of 1 : SP_2018_RD1600_191_70_20180306_00051.jpg

LM Start	1.70	Rating **	A/W	Issue No.	70
LM End	1.70	Issue Type +	Ma	Location *	LS
Category	Earthen Levee			GPS Latitude/Longitude	
				Start	End
Item	Slope Stability			38.698414 °	38.698414 °
				-121.631874 °	-121.631874 °
DWR ID	DWR_RD1600_01_f_2017_70				
Comment Code					
S2 : Repair the levee slope damaged by foot traffic and prevent access where possible.					
Inspector Comment					
Footpath on landside slope.

View of slope instability. Fall 2016.

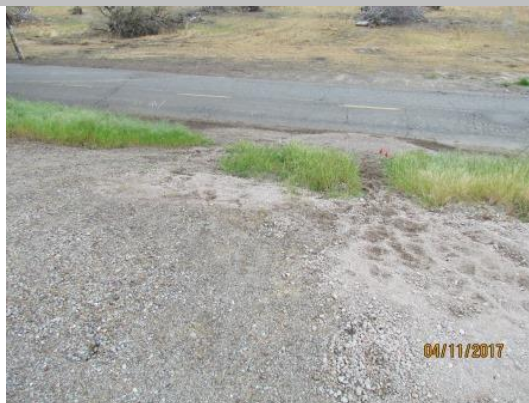
Photo 1 of 4 : SP_2018_RD1600_191_72_20180306_00055.jpg

LM Start	2.01	Rating **	M	Issue No.	72
LM End	2.01	Issue Type +	Ma	Location *	LS
Category	Earthen Levee			GPS Latitude/Longitude	
				Start	End
Item	Erosion / Bank Caving			38.701605 °	38.701605 °
				-121.627954 °	-121.627954 °
DWR ID	DWR_RD1600_01_s_2018_72				
Comment Code					
E2 : Schedule repair of erosion site prior to the next inspection.					
Inspector Comment					
Rills on landside slope.

Updated view of the erosion site. Spring 2017.

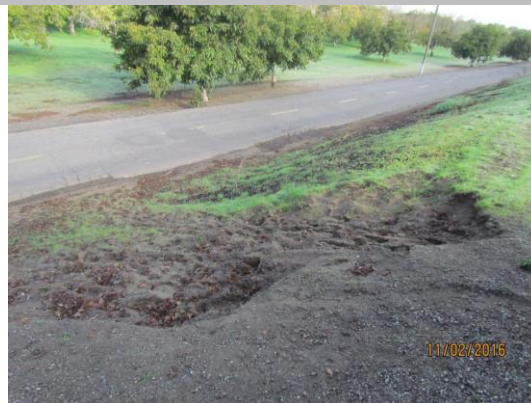
Photo 3 of 4 : SP_2018_RD1600_191_72_20180306_00053.jpg

LM Start	2.01	Rating **	M	Issue No.	72 (cont)	
LM End	2.01	Issue Type +	Ma	Location *	LS	
Category	Earthen Levee			GPS Latitude/Longitude		
				Start		End
Item	Erosion / Bank Caving			38.701605 °		38.701605 °
				-121.627954 °		-121.627954 °
DWR ID	DWR_RD1600_01_s_2018_72					
Comment Code						
E2 : Schedule repair of erosion site prior to the next inspection.						
Inspector Comment						
Rills on landside slope.

Updated view of the erosion site. Fall 2016.

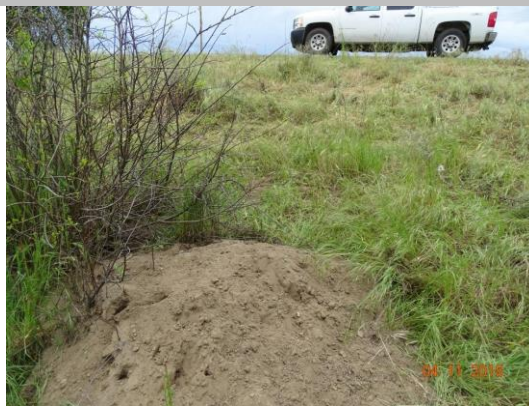
Photo 1 of 1 : SP_2018_RD1600_191_67_20180413_00099.jpg

View of rodent hole and mound on the waterside slope. Spring 2018.

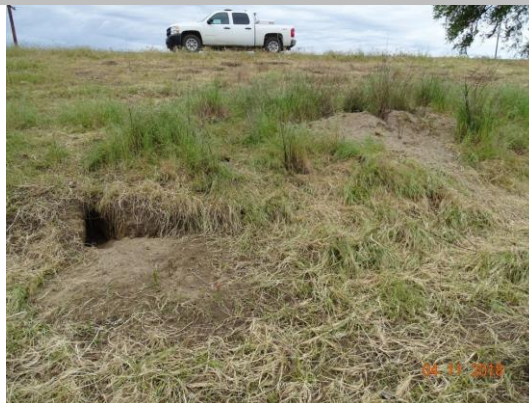
Photo 1 of 1 : SP_2018_RD1600_191_58_20180413_00098.jpg

View of rodents holes on the waterside slope. Spring 2018.

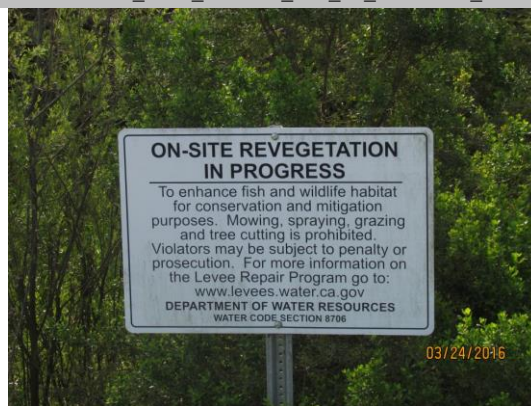
Photo 1 of 2 : SP_2018_RD1600_191_35_20180306_00034.jpg

Sign for revegetation site. Spring 2016.

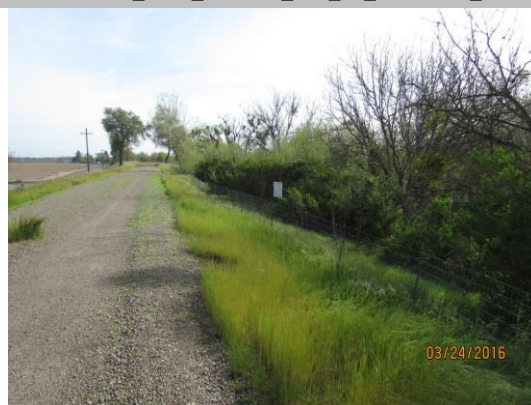
Photo 2 of 2 : SP_2018_RD1600_191_35_20180306_00035.jpg

View of the revegetation site on the waterward side of the levee looking upstream. Spring 2016.

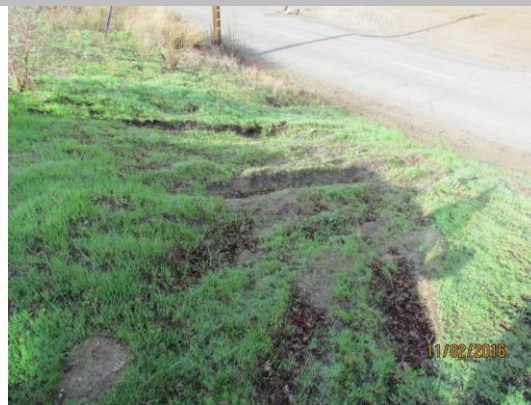
Photo 1 of 1 : SP_2018_RD1600_191_43_20180306_00038.jpg

LM Start	2.41	Rating **	M	Issue No.	43
LM End	2.41	Issue Type +	Ma	Location *	LS
Category	Earthen Levee			GPS Latitude/Longitude	
				Start	End
Item	Slope Stability			38.705203 °	38.705203 °
				-121.622184 °	-121.622184 °
DWR ID	DWR_RD1600_01_f_2016_43				
Comment Code					
S1 : Repair slope instability.					
Inspector Comment

View of slope instability on the landside slope. Fall 2016.

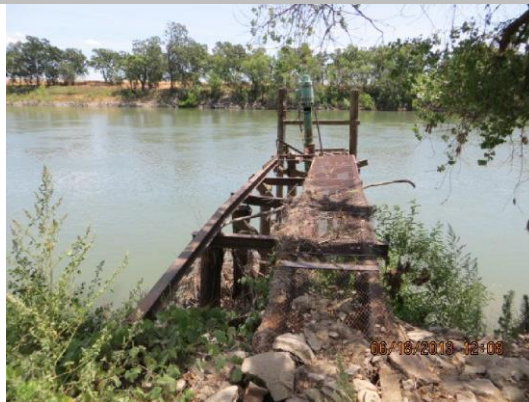
Photo 2 of 3 : UCIP_SP_2018_15108_24825.jpg

Debris buildup at metal platform waterline.

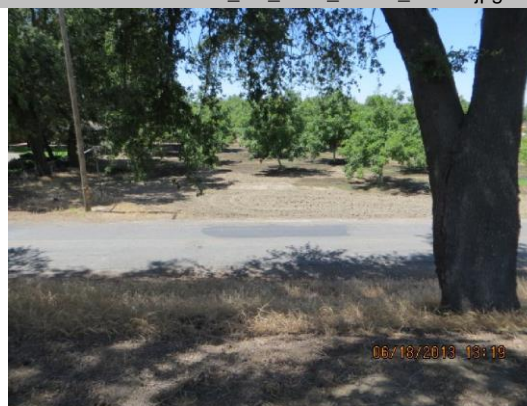
Photo 2 of 2 : UCIP_SP_2018_15110_24827.jpg

Pipe visible on LS slope.

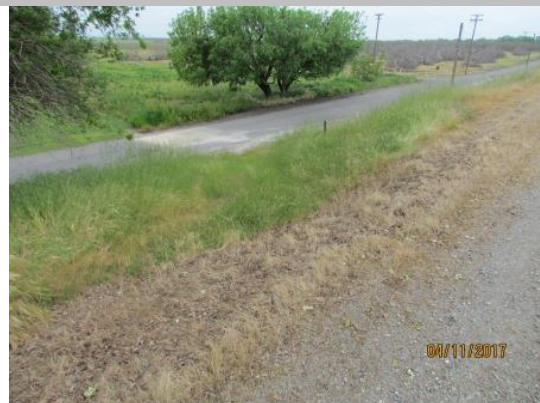
Photo 1 of 1 : SP_2018_RD1600_191_76_20180306_00057.jpg

Slope depression on landside levee slope from vehicle traffic. Spring 2017.

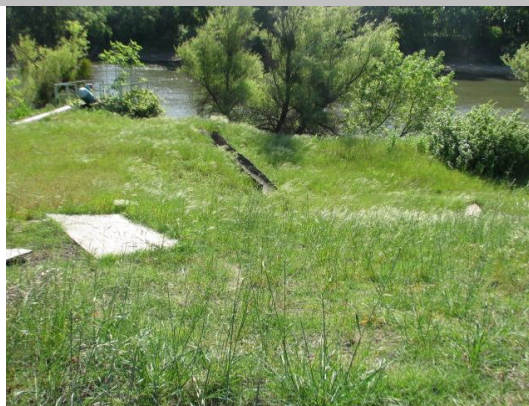
Photo 1 of 2 : SP_2018_RD1600_191_627_20180306_00069.jpg

Metal pipe and wood debris is on the waterside berm. Spring 2014

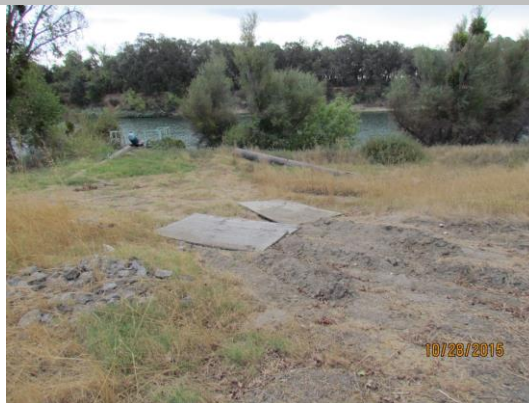
Photo 2 of 2 : SP_2018_RD1600_191_627_20180306_00070.jpg

View of the metal pipe and wood debris on the berm of the waterward side of the levee. Fall 2015.

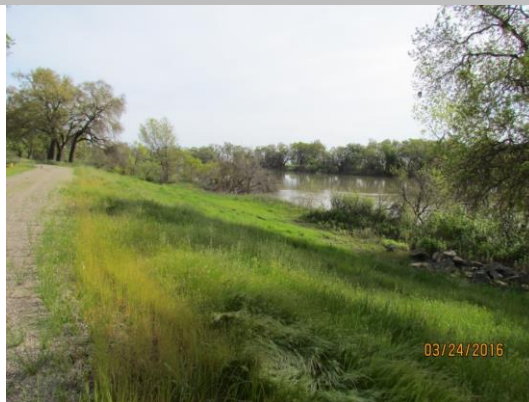
Photo 2 of 2 : SP_2018_RD1600_191_628_20180306_00072.jpg

Perspective view of the concrete pile looking upstream. Spring 2016.

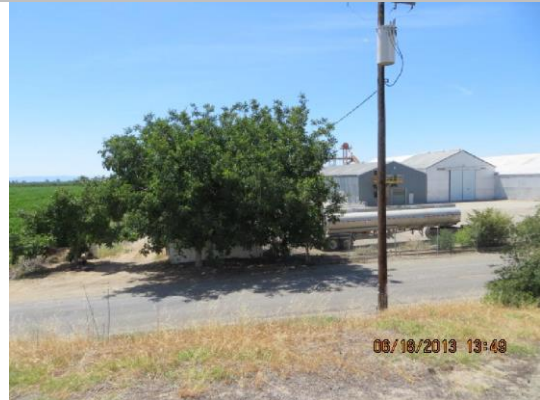
Photo 1 of 3 : UCIP_SP_2018_15125_24846.jpg

Pumphouse/distribution box off LS toe.

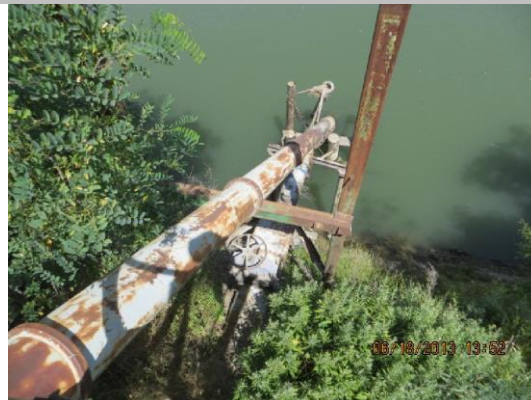
Photo 3 of 3 : UCIP_SP_2018_15125_24844.jpg

16-inch pipe ties into 24-inch pipe under pump platform at slide gate.

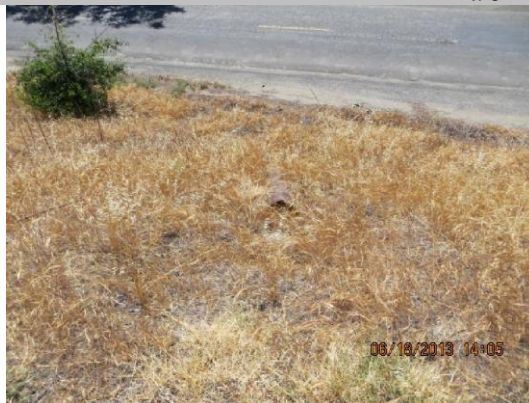
Photo 1 of 2 : UCIP_SP_2018_41563_27474.jpg

Pipe and remnants of grouted pipe on LS slope.

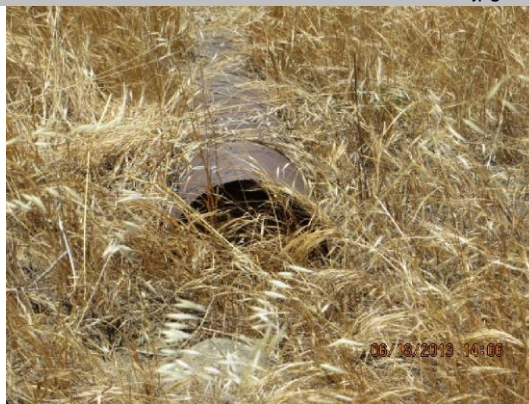
Photo 2 of 2 : UCIP_SP_2018_41563_27473.jpg

Pipe and remnants of grouted pipe on LS slope.

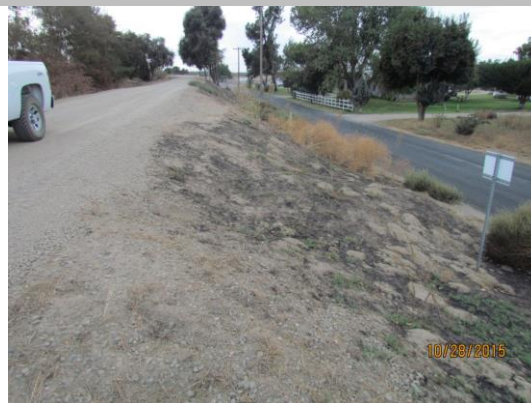
Photo 1 of 1 : SP_2018_RD1600_191_41_20180306_00037.jpg

View of the bulge at the toe of the levee on the landward side looking downstream. Fall 2015.

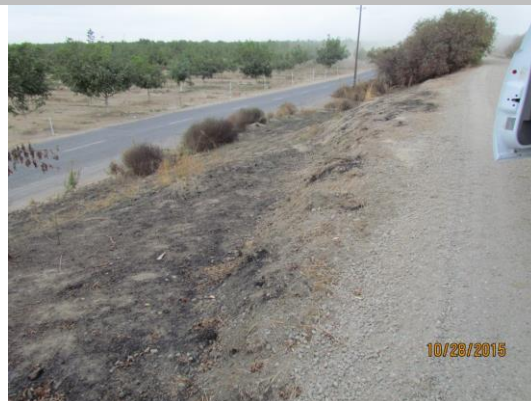
Photo 1 of 1 : SP_2018_RD1600_191_141_20180306_00066.jpg

View of the erosion on the landward side of the levee looking upstream.
Fall 2015.

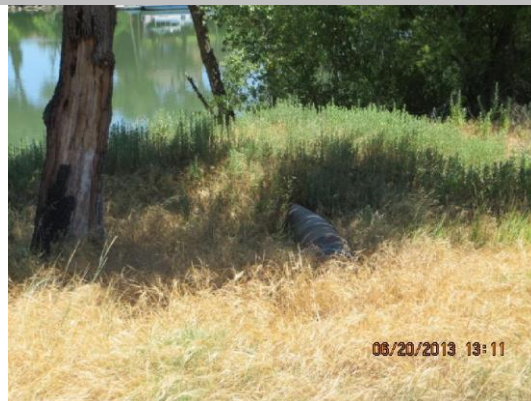
Photo 2 of 3 : UCIP_SP_2018_50101_25010.jpg

Pipe on WS slope.

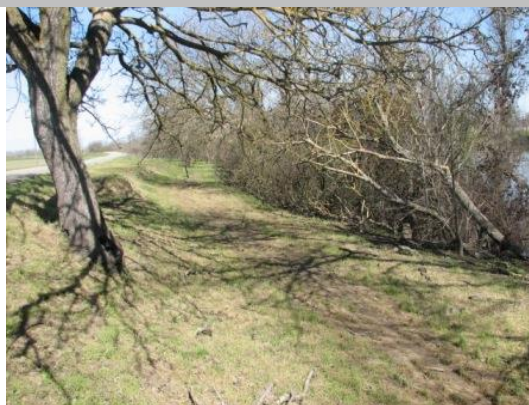
Photo 3 of 5 : SP_2018_RD1600_191_20_20180306_00015.jpg

The erosion is eroding away at the berm area.

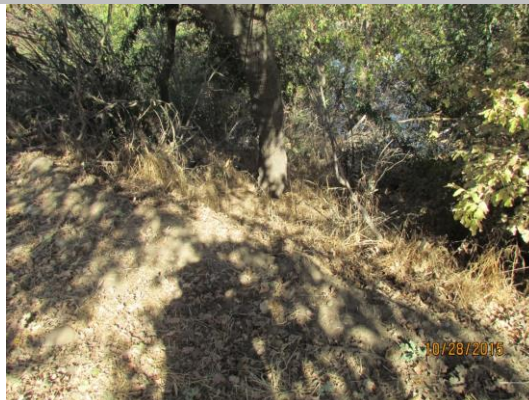
Photo 4 of 5 : SP_2018_RD1600_191_20_20180306_00016.jpg

Looking at the erosion site on the berm. Fall 2015.

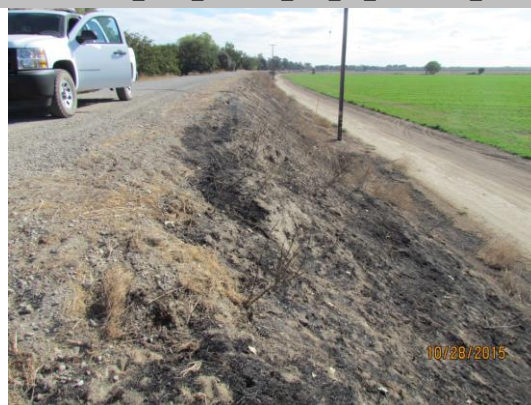
Photo 1 of 1 : SP_2018_RD1600_191_61_20180306_00047.jpg

View of the erosion on the landward side of the levee looking downstream. Fall 2015.

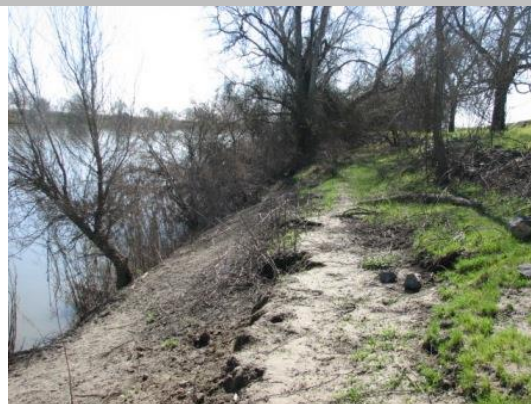
Photo 1 of 3 : SP_2018_RD1600_191_21_20180306_00018.jpg

The erosion is eroding away the berm area.

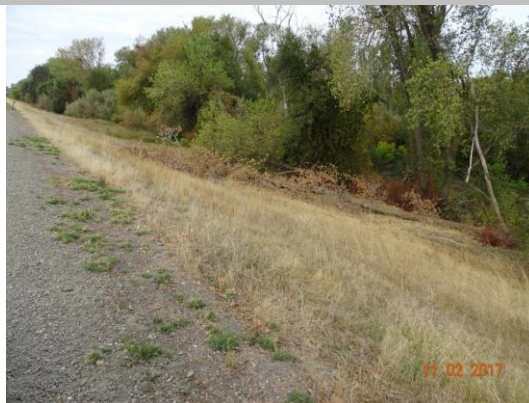
Photo 1 of 1 : SP_2018_RD1600_191_36_20180306_00036.jpg

View of fallen tree on waterside slope. Fall 2017.

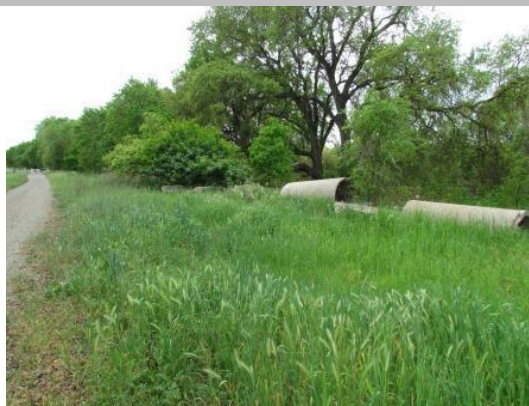
Photo 1 of 1 : SP_2018_RD1600_191_1202_20180306_00075.jpg

View of debris on the waterward side of the levee looking upstream.
Spring 2015.

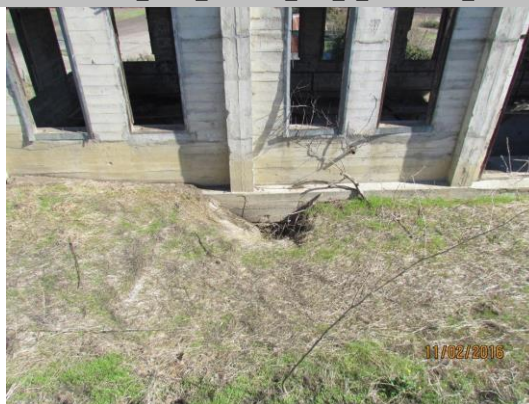
Photo 1 of 1 : SP_2018_RD1600_192_4_20180306_00001.jpg

LM Start	0.37	Rating **	M	Issue No.	4
LM End	0.37	Issue Type +	Ma	Location *	LS
Category	Earthen Levee			GPS Latitude/Longitude	
				Start	End
Item	Erosion / Bank Caving			38.730872 °	38.730872 °
				-121.633504 °	-121.633504 °
DWR ID	DWR_RD1600_02_f_2016_4				
Comment Code					
E2 : Schedule repair of erosion site prior to the next inspection.					
Inspector Comment

Landside levee slope erosion at RD1600 pumping plant. Fall 2016.

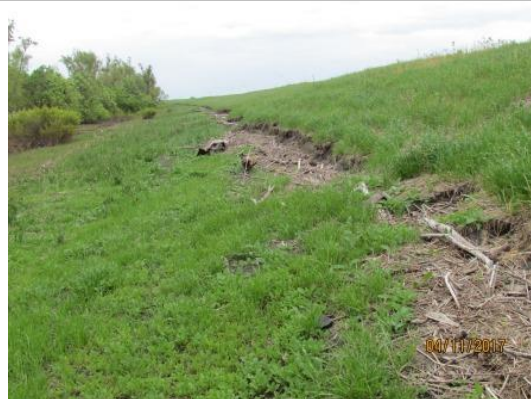
Photo 1 of 1 : SP_2018_RD1600_192_23_20180306_00019.jpg

View of wave wash damage on waterside levee slope. Spring 2017.

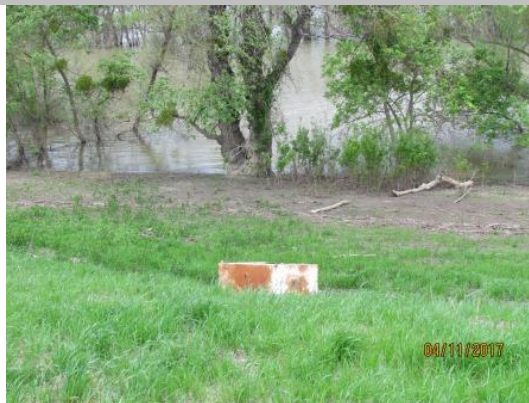
Photo 1 of 1 : SP_2018_RD1600_192_22_20180306_00018.jpg

Refrigerator on waterside levee slope. Spring 2017.

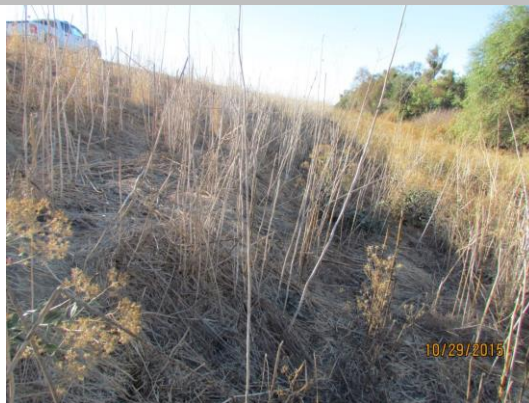
Photo 3 of 4 : SP_2018_RD1600_192_14_20180306_00009.jpg

View of the erosion on the waterward side of the levee looking downstream. Fall 2015.

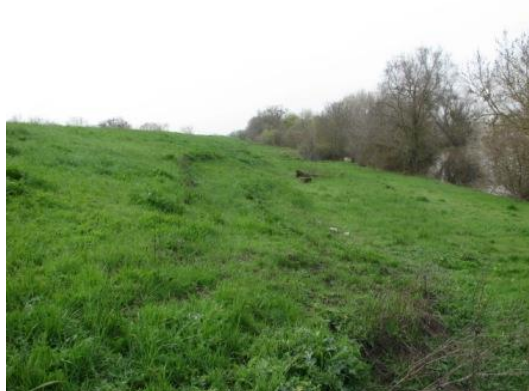
Photo 2 of 3 : SP_2018_RD1600_192_15_20180306_00012.jpg

This is wave wash damage along the toe of the levee looking downstream.

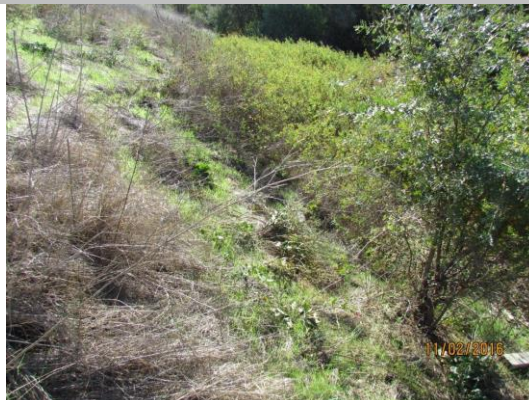
Photo 3 of 3 : SP_2018_RD1600_192_15_20180306_00013.jpg

Updated view of wave wash damage on WS slope. Fall 2016.

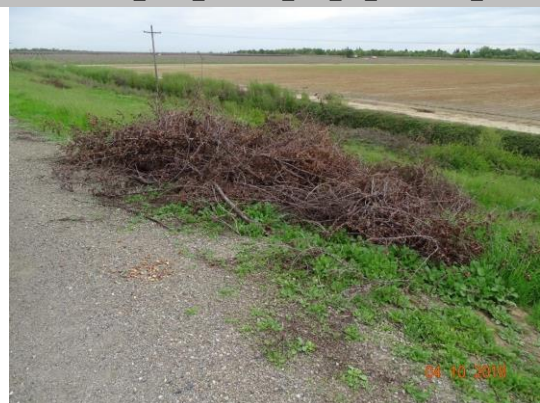
Photo 1 of 1 : SP_2018_RD1600_192_10_20180413_00026.jpg

View of pruning pile on the landside slope. Spring 2018.

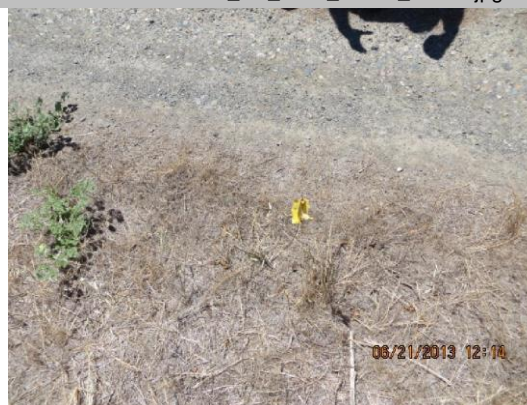
Photo 1 of 2 : UCIP_SP_2018_50099_27478.jpg

PG&E marker flag on Crown.

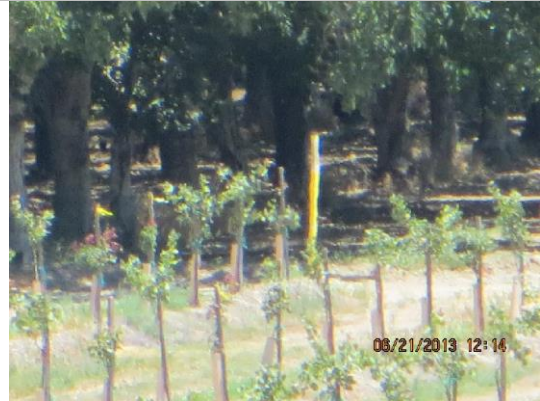
Photo 2 of 2 : UCIP_SP_2018_50099_27477.jpg

Carsonite gasline marker visible approximately 1,000-feet east of levee crown.

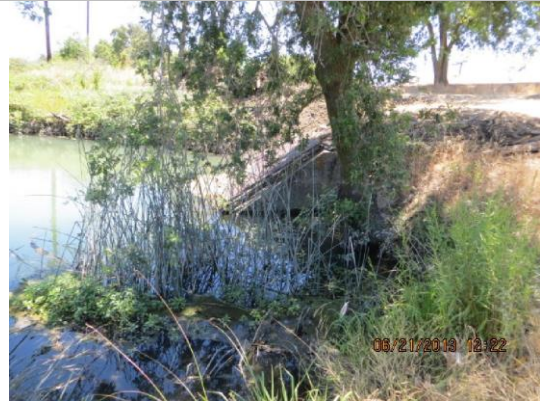
Concrete intake structure on LS.

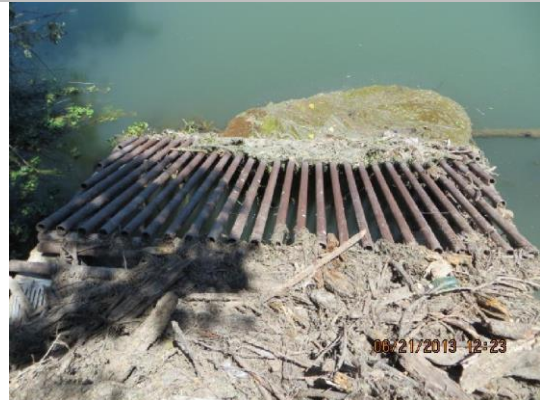
Concrete intake structure on LS.
